Docket No. 217 – Development and Management Plan Inspection

Northeast Utilities Service Company Certificate of Environmental Compatibility and Public Need for the construction of a 345-kV electric transmission line and reconstruction of an existing 115-kV electric transmission line between Connecticut Light and Power Company's Plumtree Substation in Bethel, through the towns of Redding, Weston, and Wilton, and to the Norwalk Substation in Norwalk, Connecticut.

Date: May 27, 2004

Location: Norwalk Substation Expansion

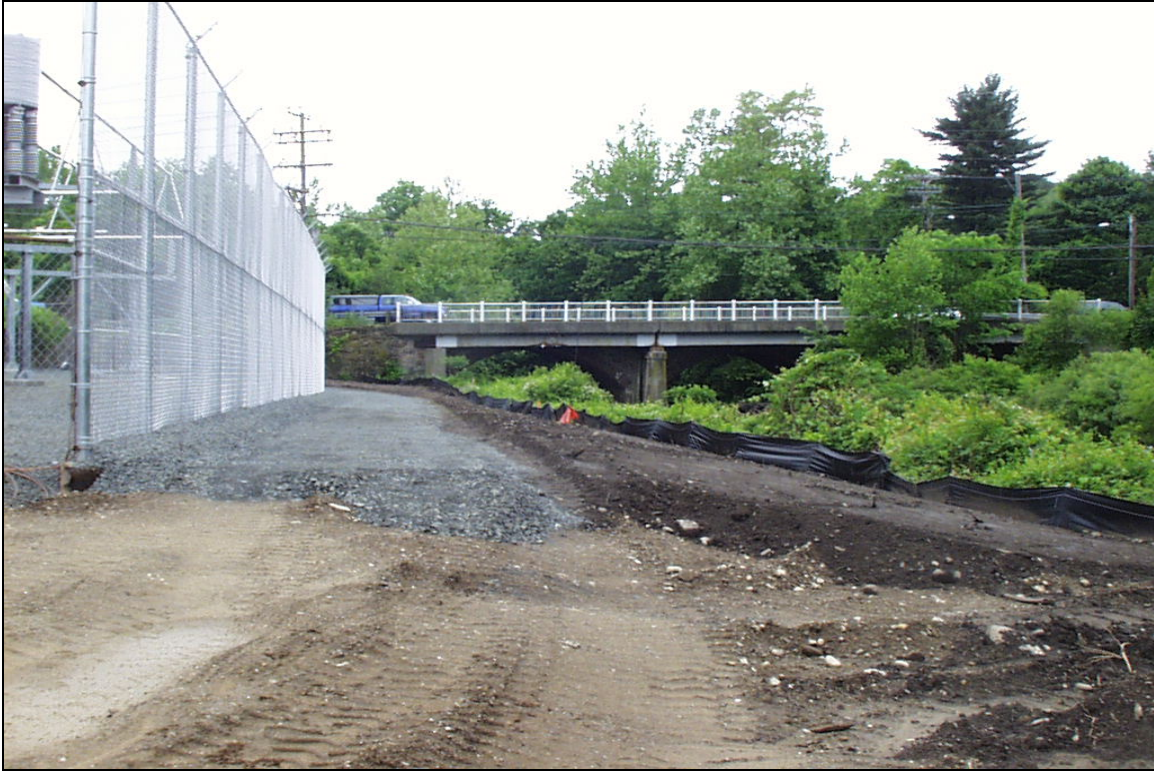
- Topsoil and seed have been placed between the bike path and silt fence at the southern end of the site. 5/27/04	- Monitor growth of vegetation and place some straw mulch for cover. 5/27/04

A STONE BASE HAS BEEN INSTALLED ON THE SOUTHERN PORTION OF THE BIKE PATH. AREAS HAVE BEEN FILLED AND SEEDED BUT COULD USE SOME MULCH.
5/27/04

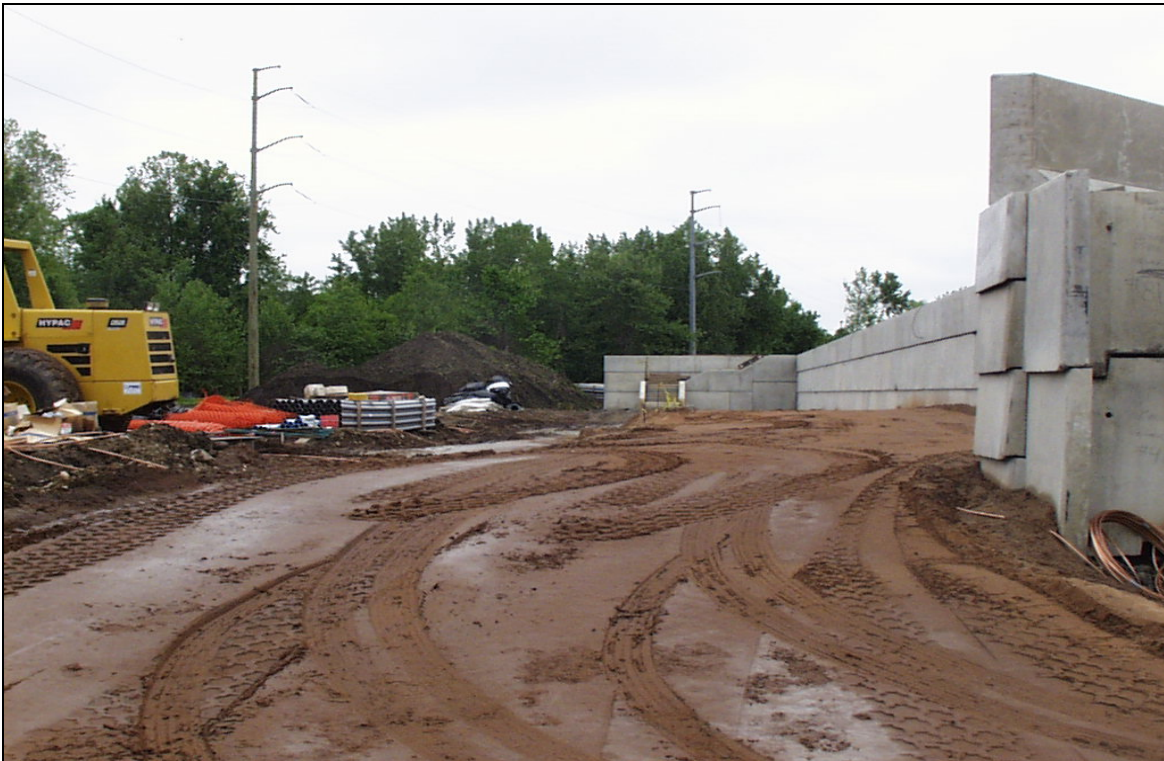
VIEW OF SITE BEHIND WALLS 1 AND 2. 5/27/04

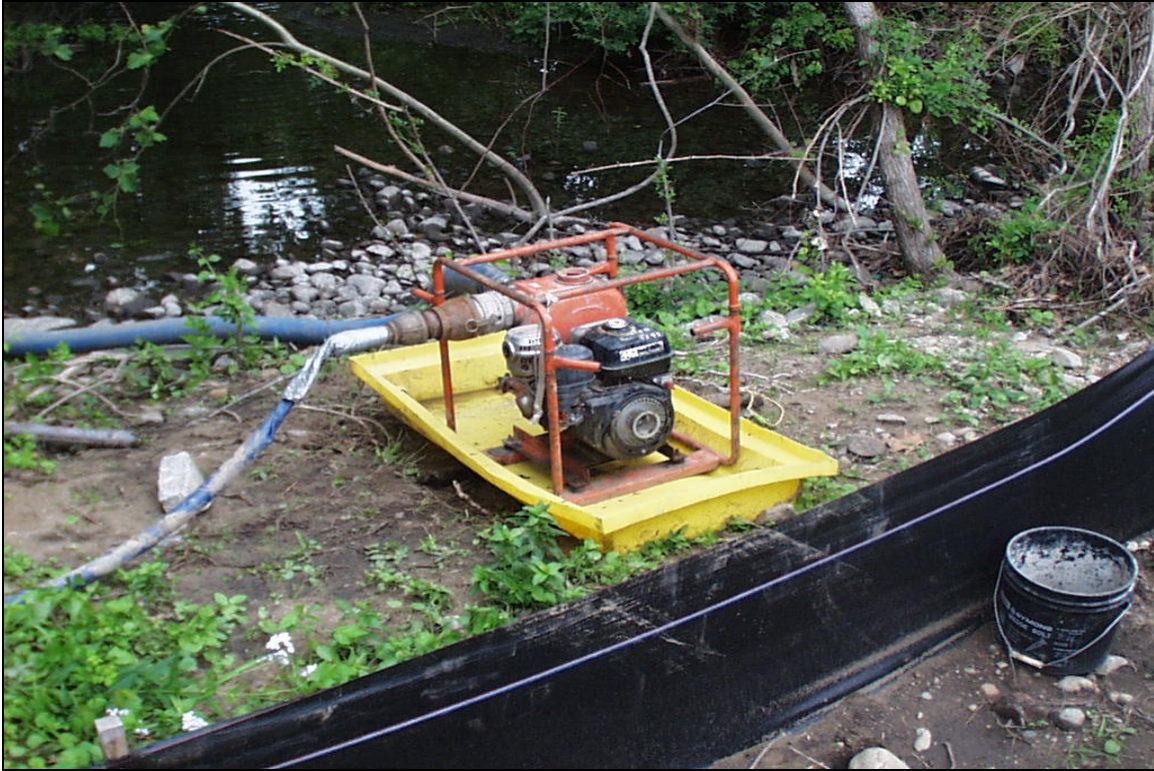
Areas of Inspection	Observation	Recommended Action
Erosion and Sediment Controls contd.	- Small amounts of water from the river are being used to wet portions of the soil on site to help with compaction. 5/27/04	- These areas are well contained and the pump was properly placed in secondary containment. 5/27/04

VIEW OF PUMP IN PROPER SECONDARY CONTAINMENT WHILE NEAR THE RESOURCE AREA. 5/27/04

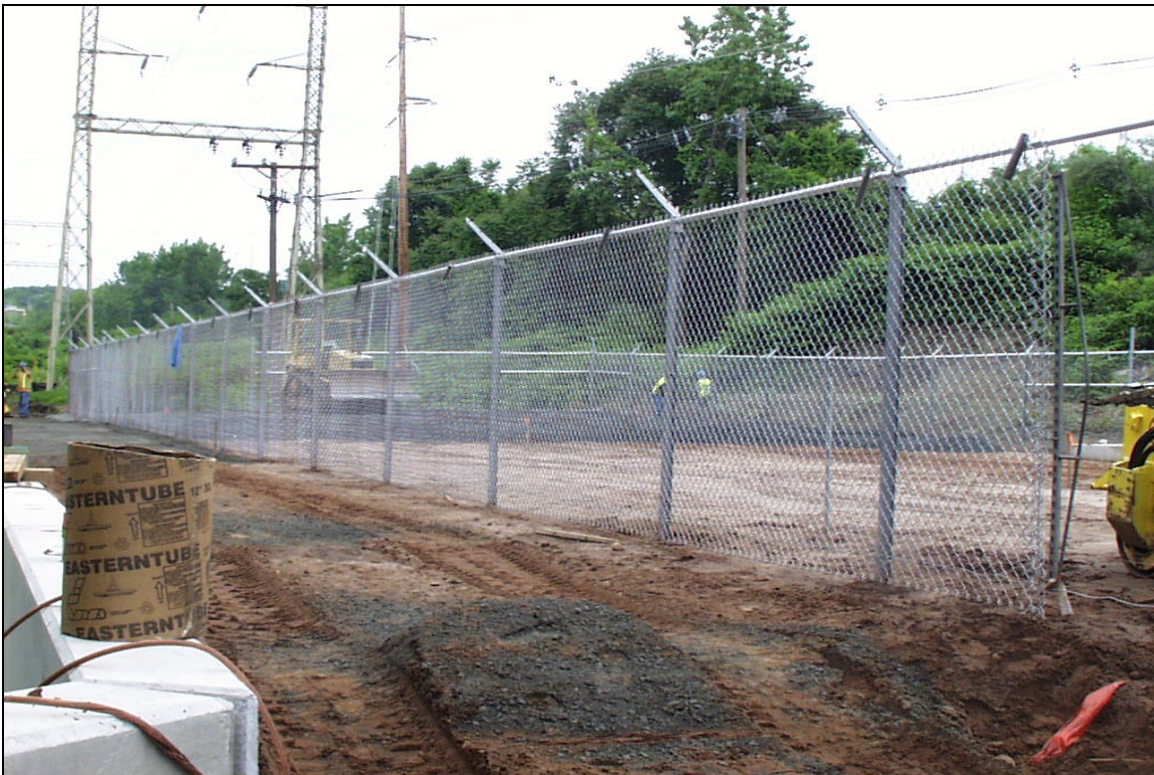
THE AREA TOWARDS THE NORTH OF THE SITE HAVE BEEN FENCED IN AND A STONE BASE IS BEING INSTALLED. THE BIKE PATH WORK IS ALSO ONGOING HERE. 5/27/04

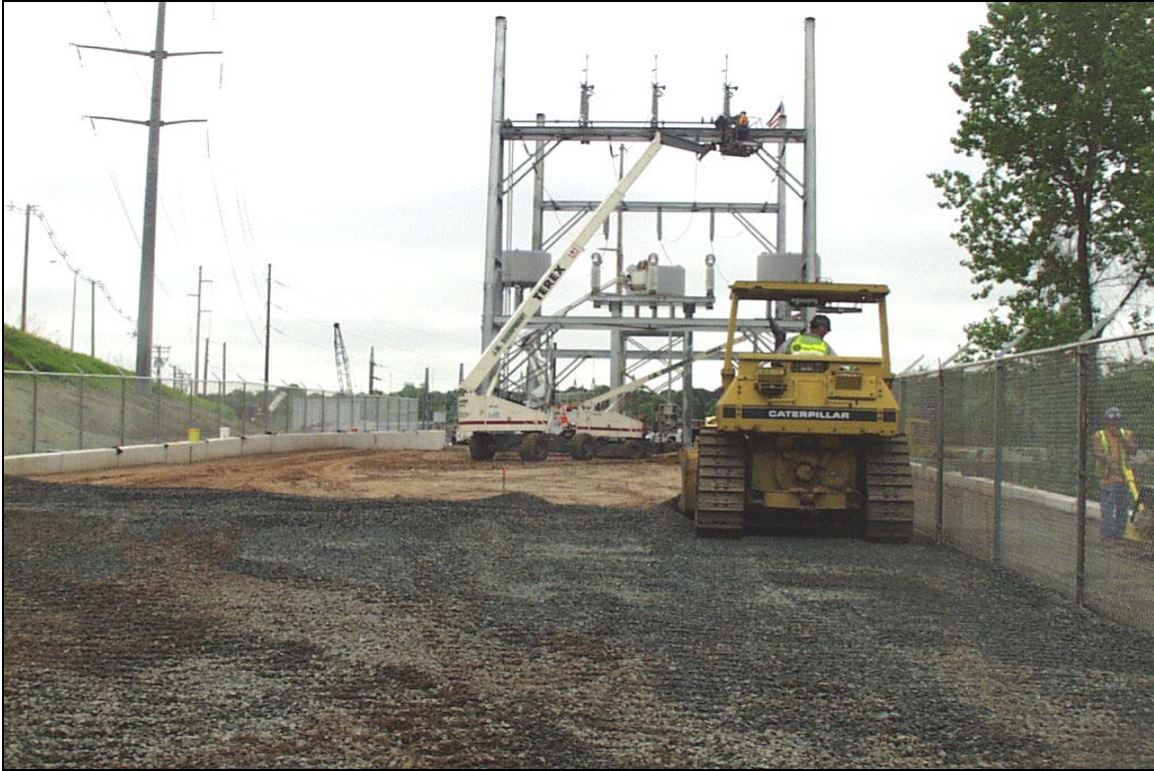
VIEW OF STONE BASE BEING INSTALLED WITHIN THE FENCED-IN NORTHERN PORTION OF THE YARD. 5/27/04

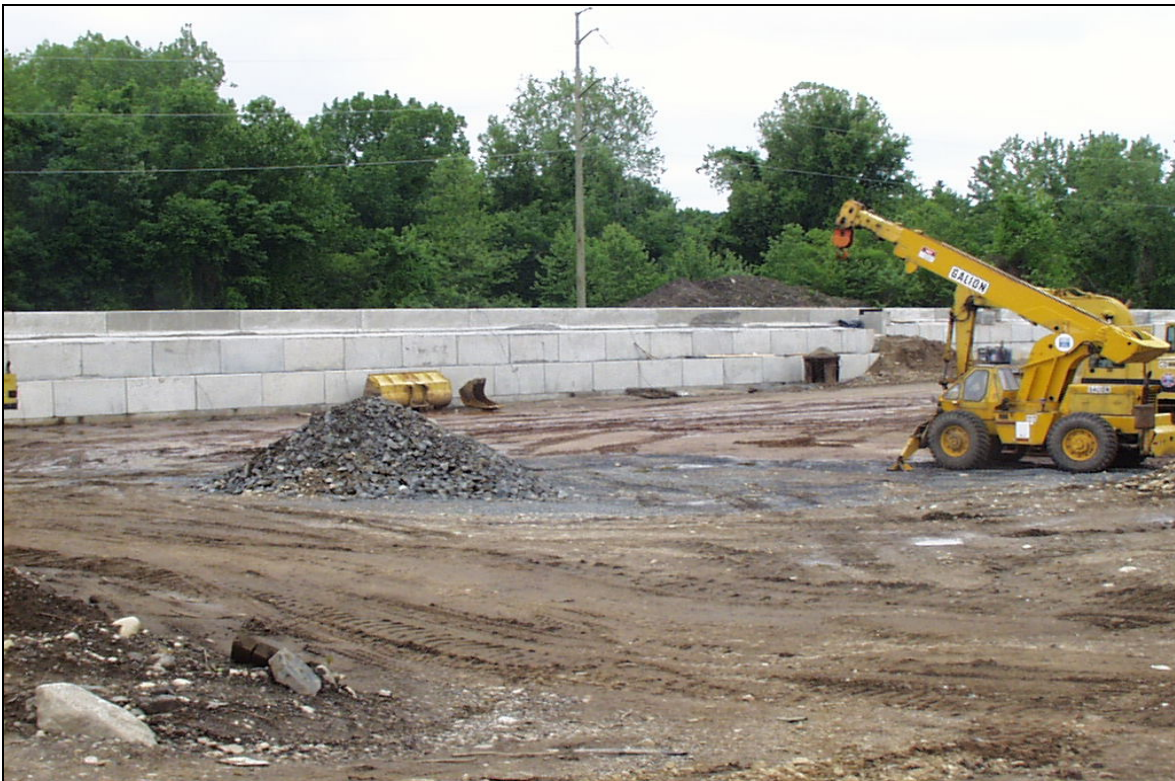
<ul style="list-style-type: none"> - Topsoil is still being removed from the southern end of the stockpile to be utilized on site. Portions of the pile remain. 5/27/04 	<ul style="list-style-type: none"> - The pile appears fairly stable but should continue to be monitored. Plans are ongoing to utilize most of the soil in the near future. 5/27/04
	<ul style="list-style-type: none"> - The concrete washout station was cleaned out and is ready for use. Efforts to use this station have been good. 5/27/04 	<ul style="list-style-type: none"> - The main objective is to keep all washout water from resource areas and storm drains. Continue to utilize and maintain designated stations for concrete. 5/27/04
	<ul style="list-style-type: none"> -The old Monroe soil area has been excavated at or below the original grade and has been confirmed by survey. 5/27/04 	<ul style="list-style-type: none"> - Backfill can occur upon approval and concurrence of these grades. 5/27/04

VIEW LOOKING TOWARDS THE OLD EXCAVATION AREA. ORIGINAL GRADES ARE BEING CONFIRMED AND THEN BACKFILL CAN OCCUR. 5/27/04

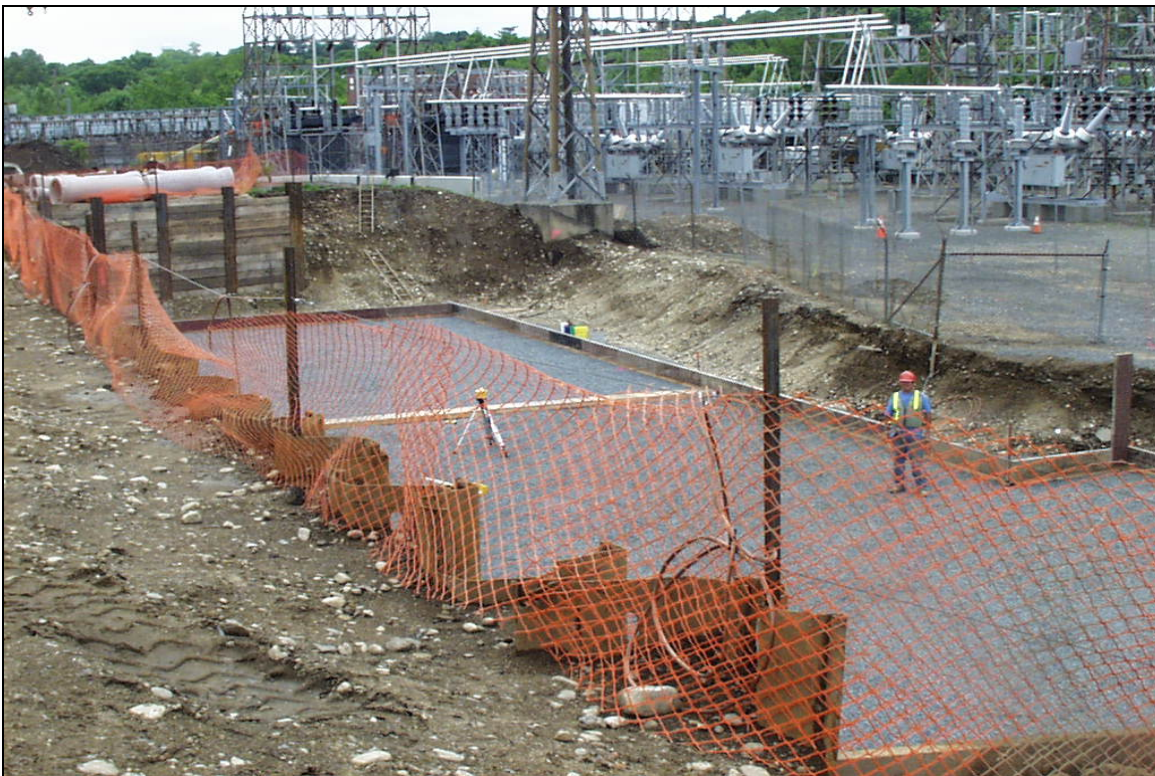
VIEW OF FOUNDATION WORK ON THE CONTROL BUILDING. 5/27/04
